Surviving disaster – The Titanic and SOLAS

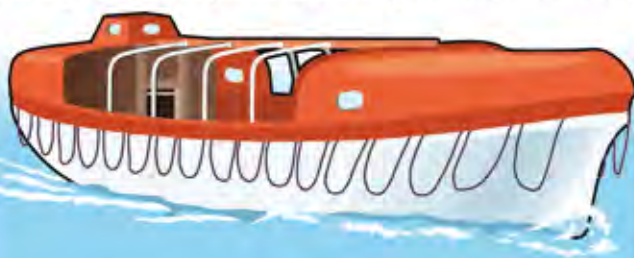
Lifeboat design

Some people died from hypothermia in the Titanic lifeboats because they were open and gave no protection against the cold. Under SOLAS, lifeboats must be fully or partially enclosed. On passenger ships, partially enclosed lifeboats can be used as they are easier to get into, but they must have a collapsible roof to fold across.

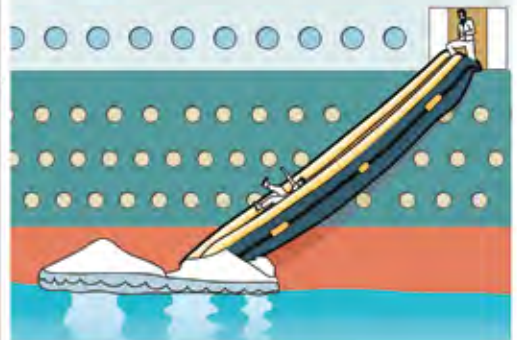
Evacuation chutes

Passengers on the Titanic jumped from windows and doorways into the lifeboats as they were lowered, often injuring themselves or other passengers. New emergency evacuation chutes are both safer and quicker.
